Manhole Inspection Summary

Manhole # S37Q__002MH

Location Address: **424 sanders st**

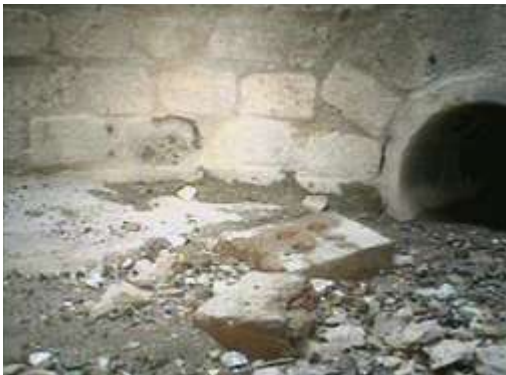
Defect 2

Condition: ☐ Sound ☐ Cracked ☐ Root Intrusion ☐ Deteriorated ☐ Leaks ☒ **Debris**

channel debris

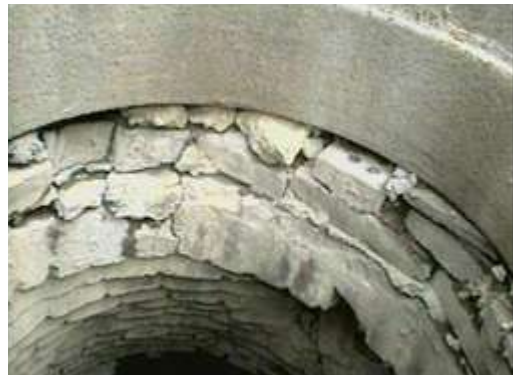
Defect 1

Condition: ☐ Sound ☐ Cracked ☐ Root Intrusion ☒ **Loose Brick** ☐ Deteriorated

corbel loose brick
